# SEE and TID Qualification of the ELMB128 Series Production

H. Boterenbrood<sup>1</sup> and B. Hallgren<sup>2</sup>

**Abstract:** Twelve ELMB128 boards from the series production were exposed to 60 MeV protons to a total fluence of  $1.2 \cdot 10^{12}$  protons/cm<sup>2</sup>. Each board received concurrently a TID dose of 140 Gy. No destructive or permanent SEE error occurred but one of boards failed during the reprogramming of the flash memory. The number of functional soft SEEs amounted to 3. The different components of the ELMB, ATmega128 processor, CAN controller SAE81C91 and the ADC CS5523 were subject to a systematic study of their SEE cross-section. Measurements were also made on the Agilent Technologies optocouplers HCPL-0731.

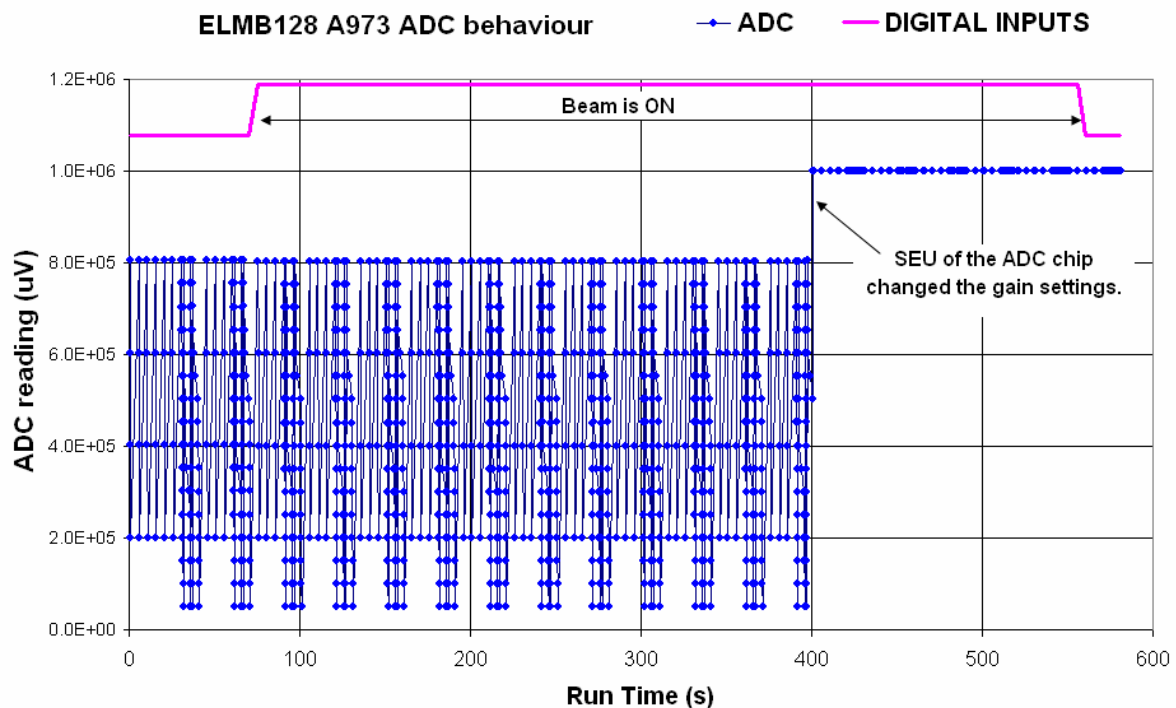
As shown in the Figure 2 the readout of the ADC is in overflow conditions ( = 1.0E6  $\mu$ V ) from run-time = 400s. All of the ADC channels behaved similarly. The condition was not detected on-line. But a manual or automatic re-initialising of the ADC (soft-reset) should have cleared this condition.

Figure 2 The normal readout of all the 64 ADC channels is shown until the time 400s. At this time one SEE in the ADC chip changed the gain settings. The digital inputs indicates the time during which the beam was on.

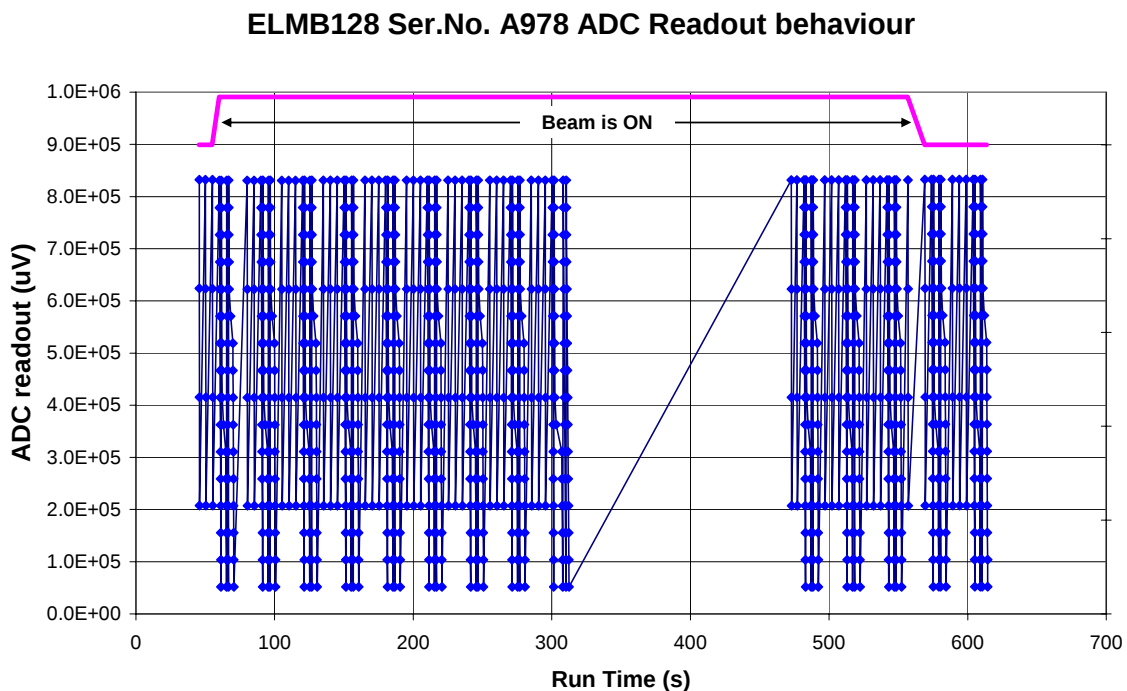
The ELMB stopped to send data after 312s, see Figure 3. The CAN controller was set to auto-answer to a particular request (a so called Remote Frame Request or RTR), see Figure 4. This still worked, but a toggle bit in this reply was not updated. This means that the program in the microcontroller was not running properly. Software reset messages were sent manually with no effect. Therefore a power cycling was done manually at the time 460s and normal operation resumed.

Figure 3 The normal ADC readout of 64 channels ELMB Ser.No. A978 stopped at 312s and resumed at 470s.

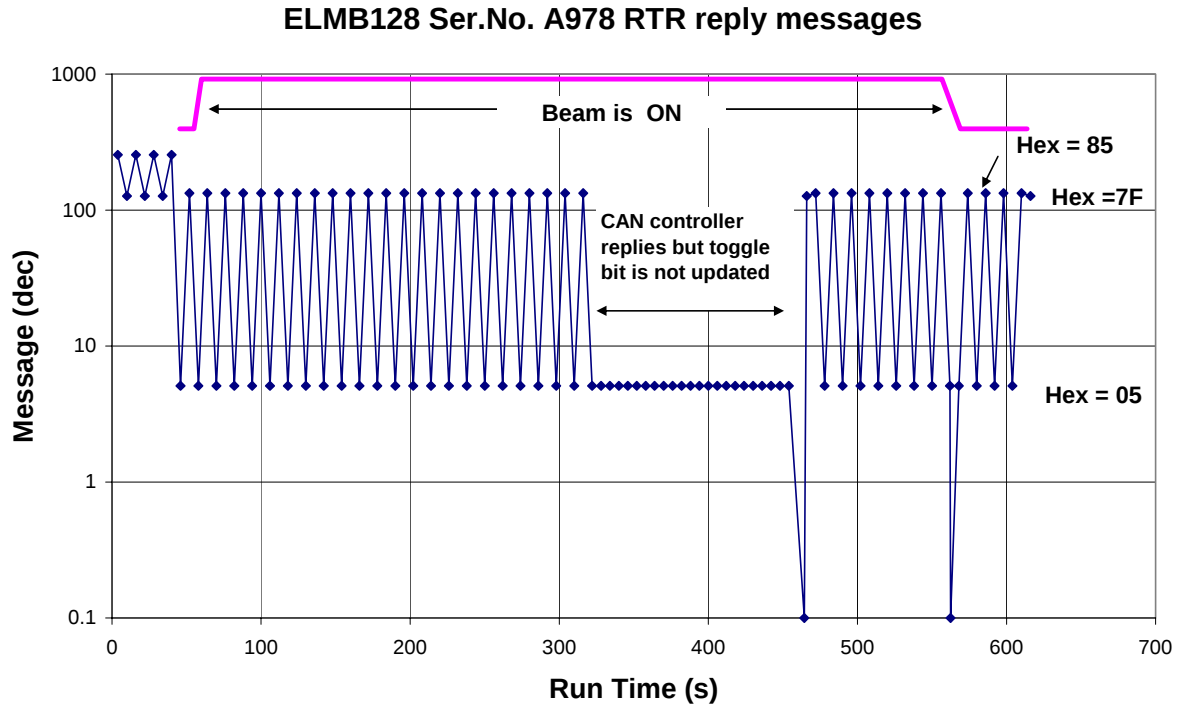
Figure 4 RTR messages showing the CAN controller replies but the toggle bit is not updated

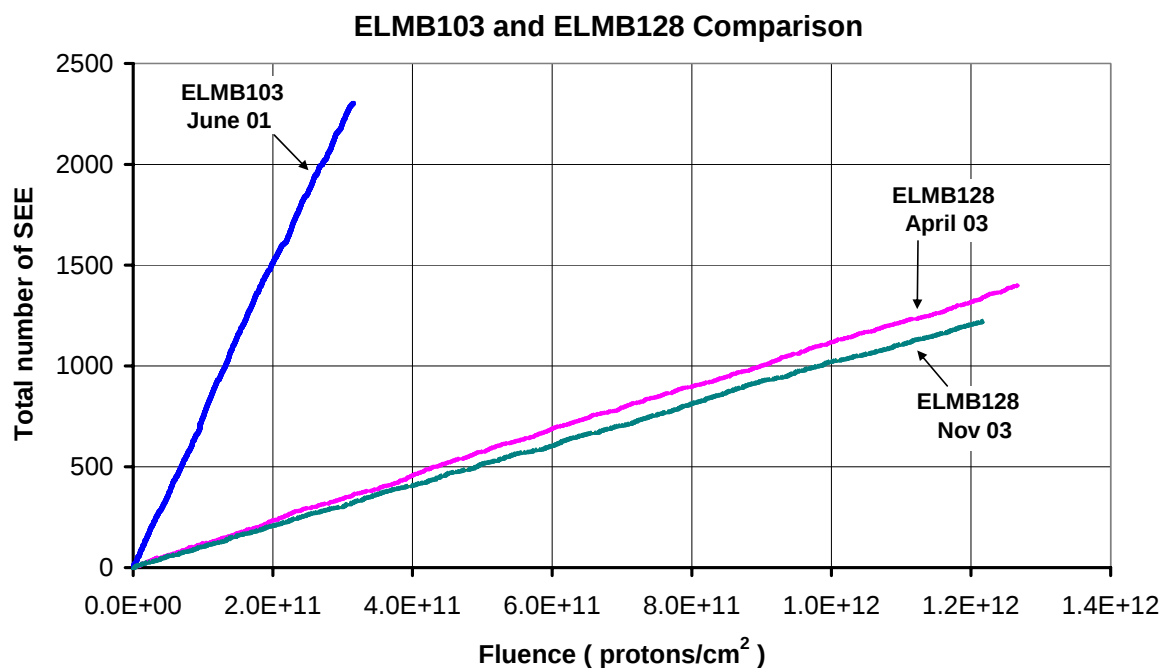
The test covered 2 kBytes of the processor's embedded SRAM. Figure 5 shows the total number of SEEs detected versus the fluence for the current as well as the two earlier irradiation tests. Note the difference in slope between the most recent tests and the oldest test. This is due to a change in technology of the processor from 0.5  $\mu\text{m}$  to 0.35  $\mu\text{m}$ . The slopes for the old and new technologies are  $3.6 \cdot 10^{-12}$  respectively  $5.4 \cdot 10^{-13}$  and  $4.9 \cdot 10^{-13}$  per byte and proton/ $\text{cm}^2$ .

Figure 5 Total numbers of SEEs for three different processor versus fluence

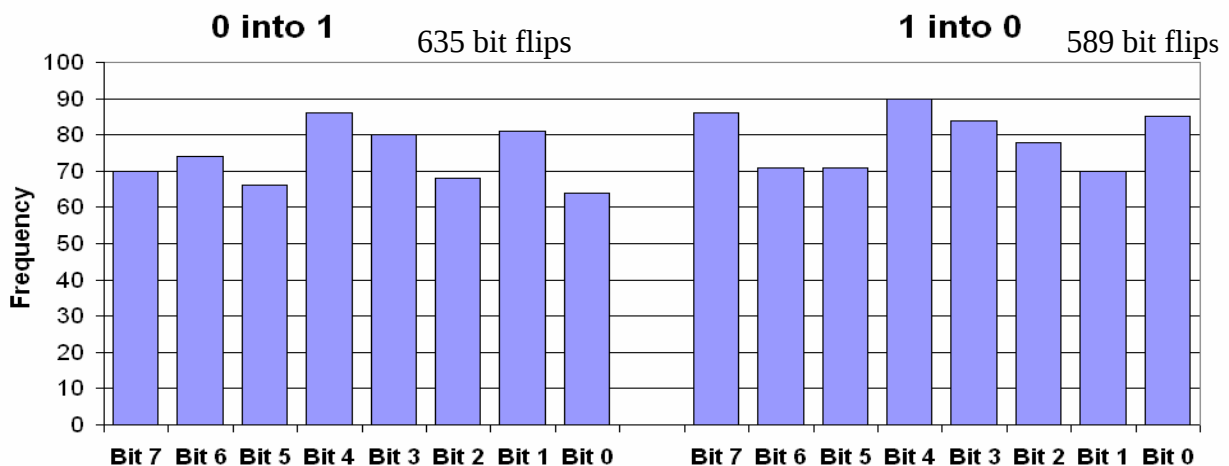
Figure 6 Number of changes from 0 to 1 and 1 to 0 in the 8 bits of the SRAM bytes The number of SEEs was 1224 single bit flips evenly distributed over bits and polarity.

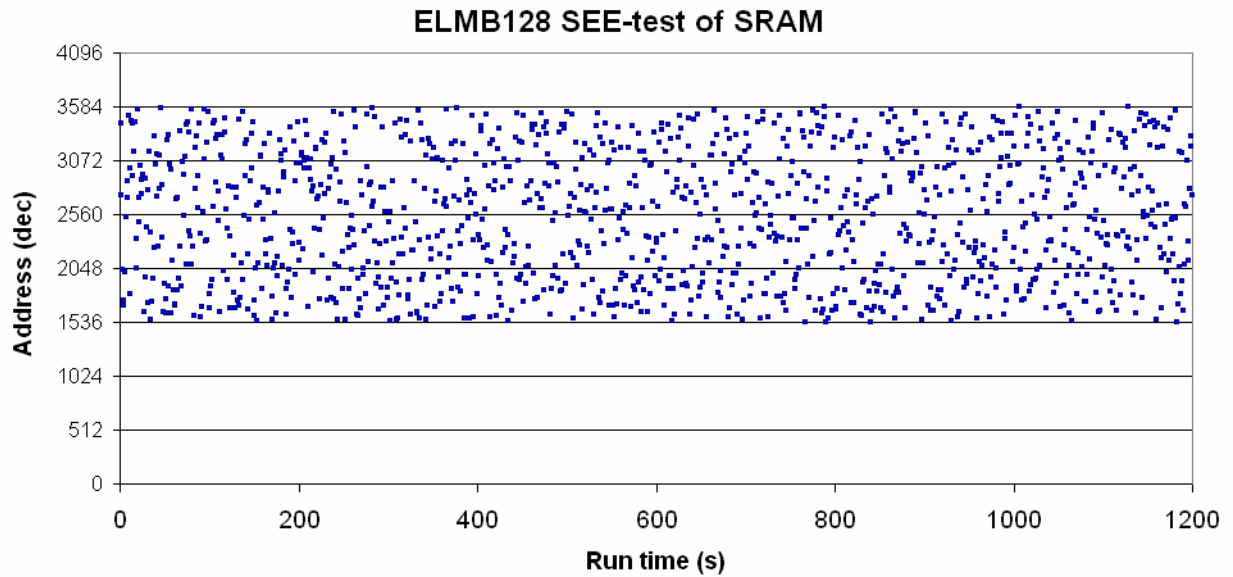
The test involved addresses 0x600 to 0xDFF (1536 to 3583 in decimal). Figure 7 indicates for each SEE in SRAM the address where it was located during the run-time. Figure 8 shows the even distribution of the SEEs over the different addresses.

Figure 7 Addresses of the SRAM where the SEEs were located versus run-time

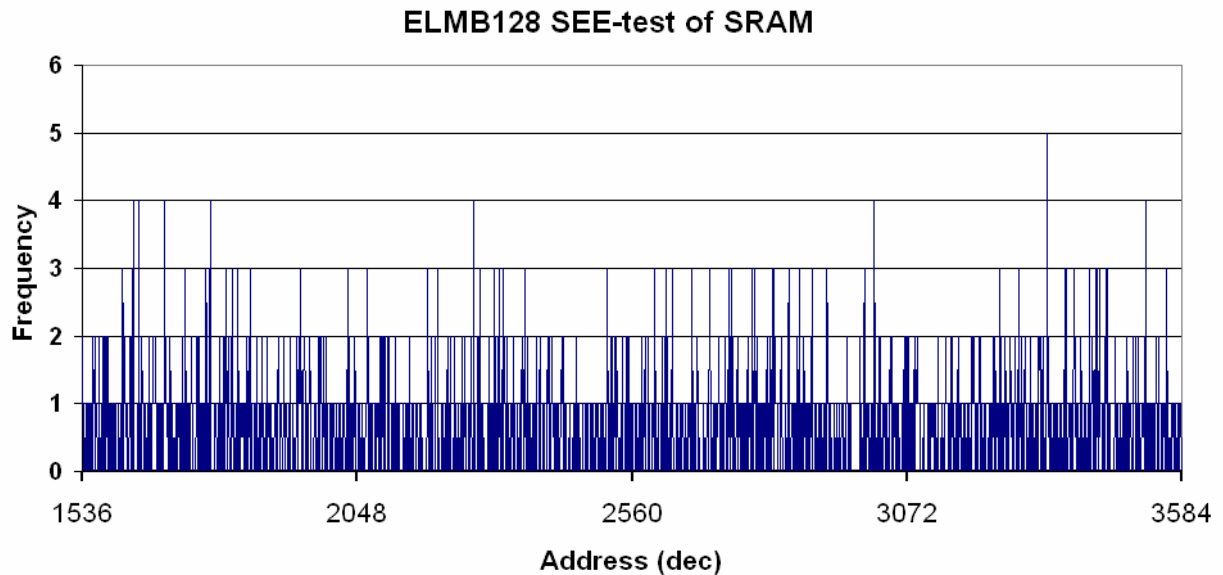
Figure 8 Number of SEEs detected in all the ELMBs per address in the SRAM

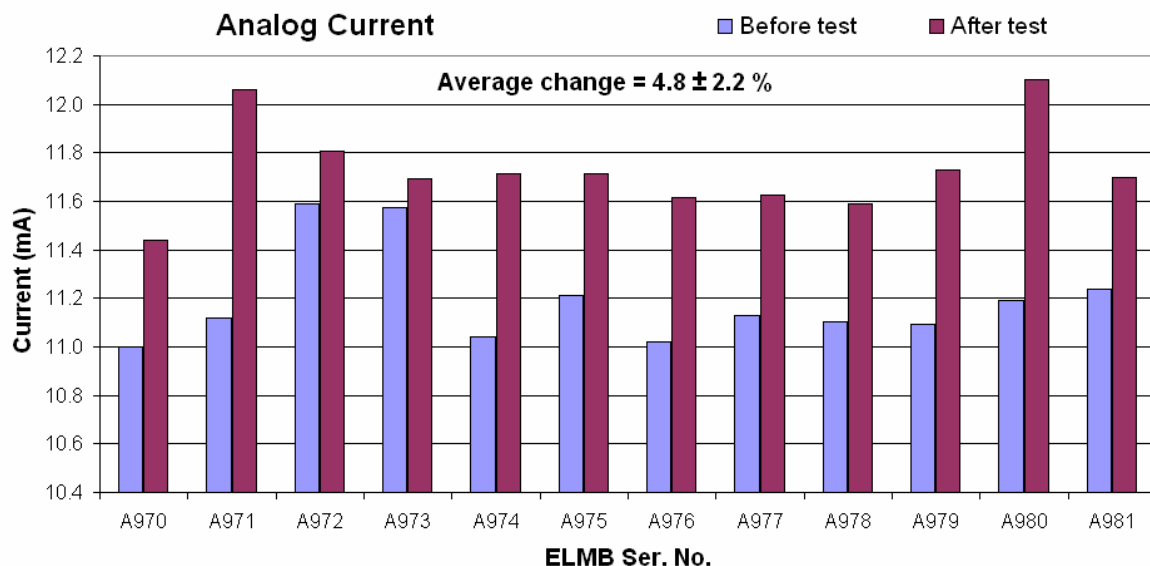
The analog, digital and CAN power supply currents were measured with the test box at CERN before the test and at CERN after the test. The differences between the two values are displayed in the charts below. They are all very small and within the specification.

Figure 11: Change in the analog current after the irradiation

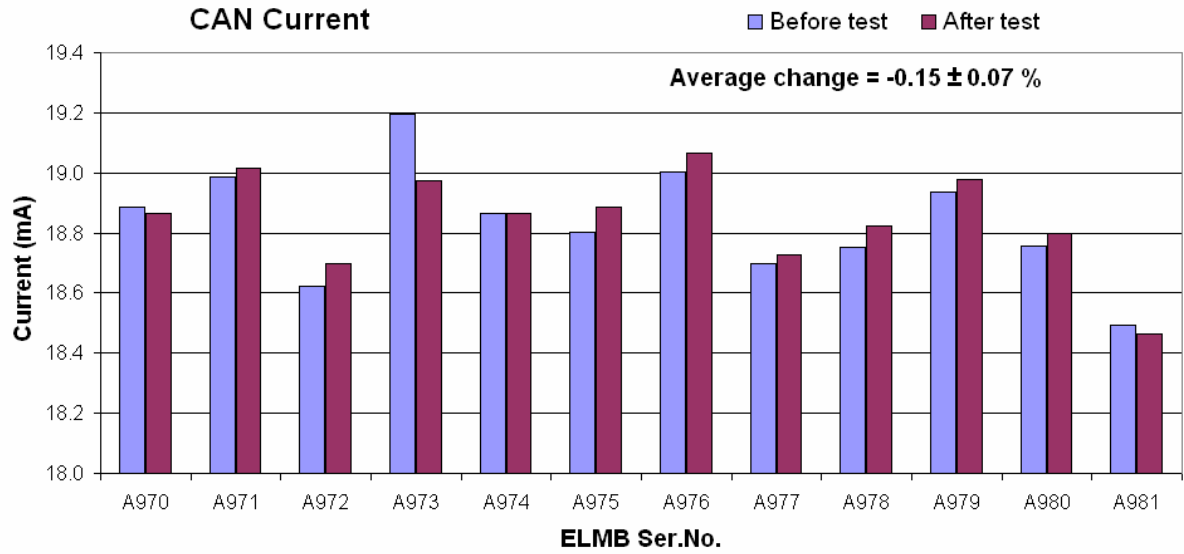
Figure 12: Change in the CAN current between the beginning and the end of the test

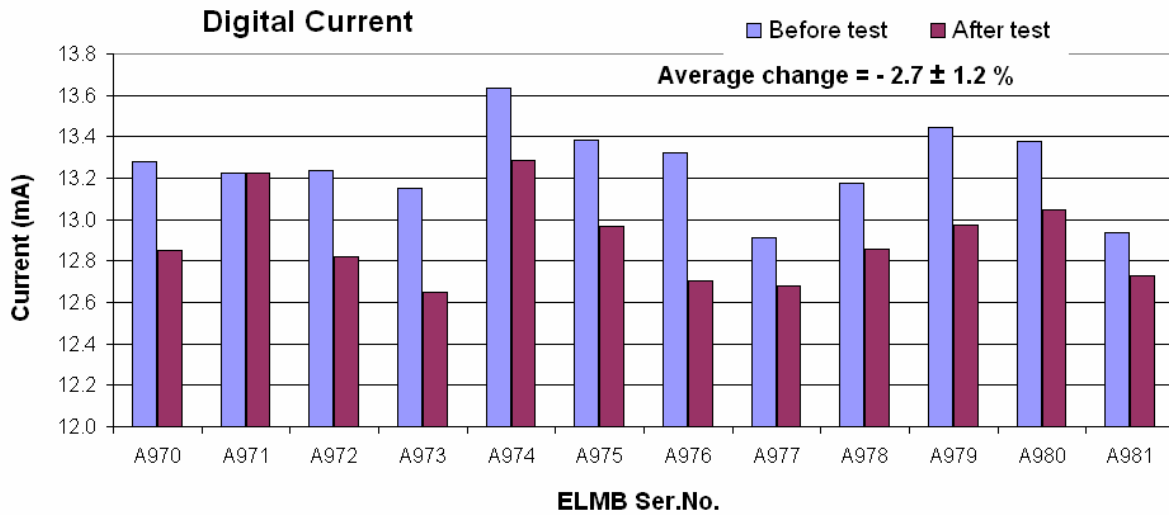
Figure 13: Change in the digital current between the beginning and the end of the test

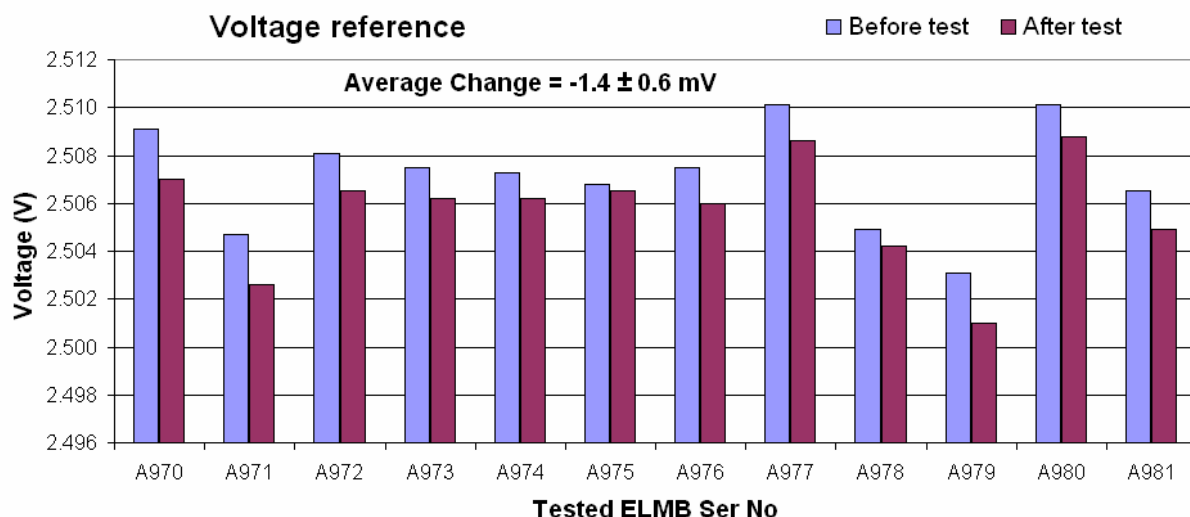
The ADC voltage reference AD680JR was very stable ( $10^{-3}$ ).

Figure 14 Change in the ADC voltage reference is -0.06%

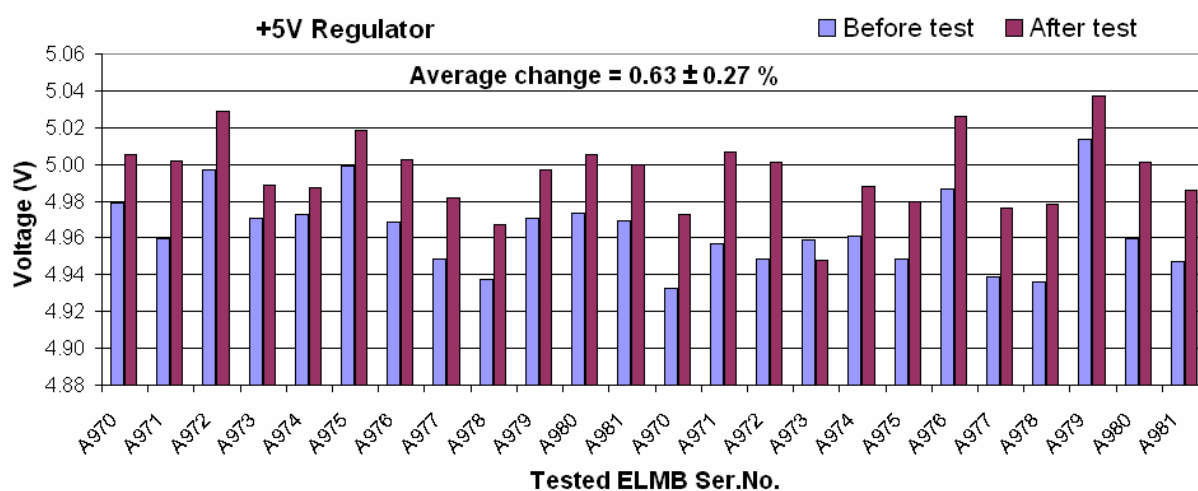
The voltages of the analog, CAN and digital regulators changed slightly but stayed within the specification of  $\pm 3\%$ .

Figure 15 Changes in the 5V regulator

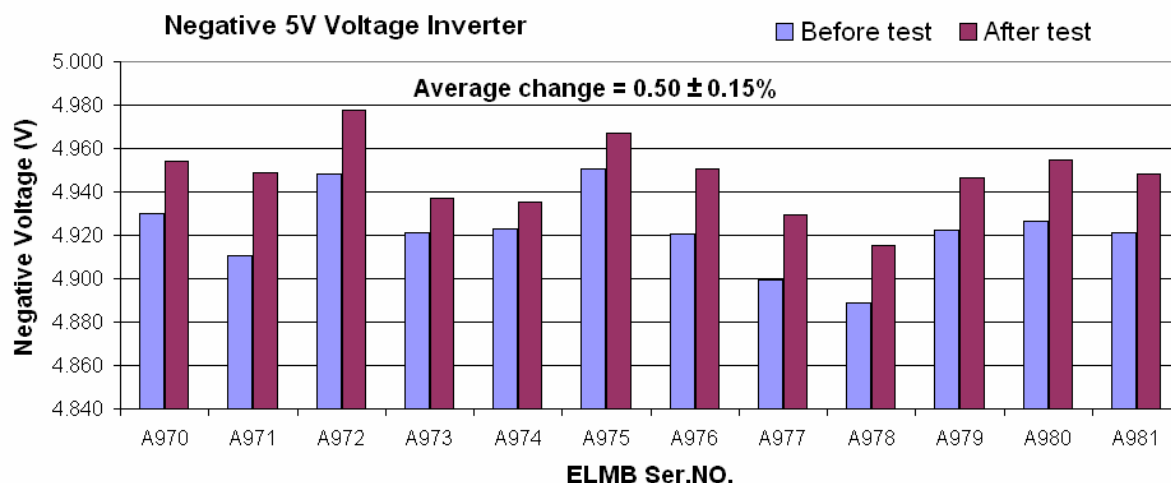
Figure 16 Changes in the -5V voltage inverter

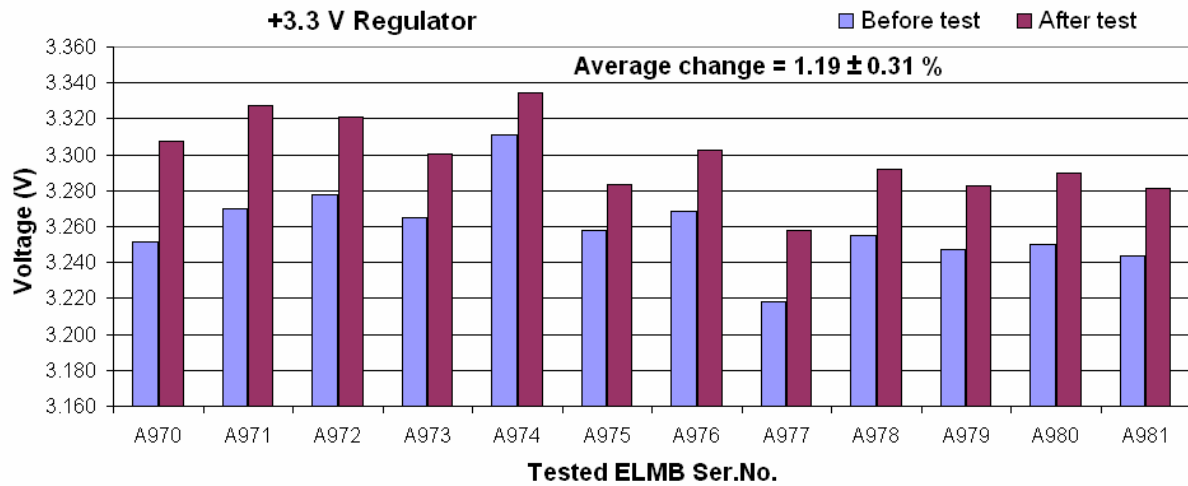
Figure 17 Changes in the 3.3V regulator

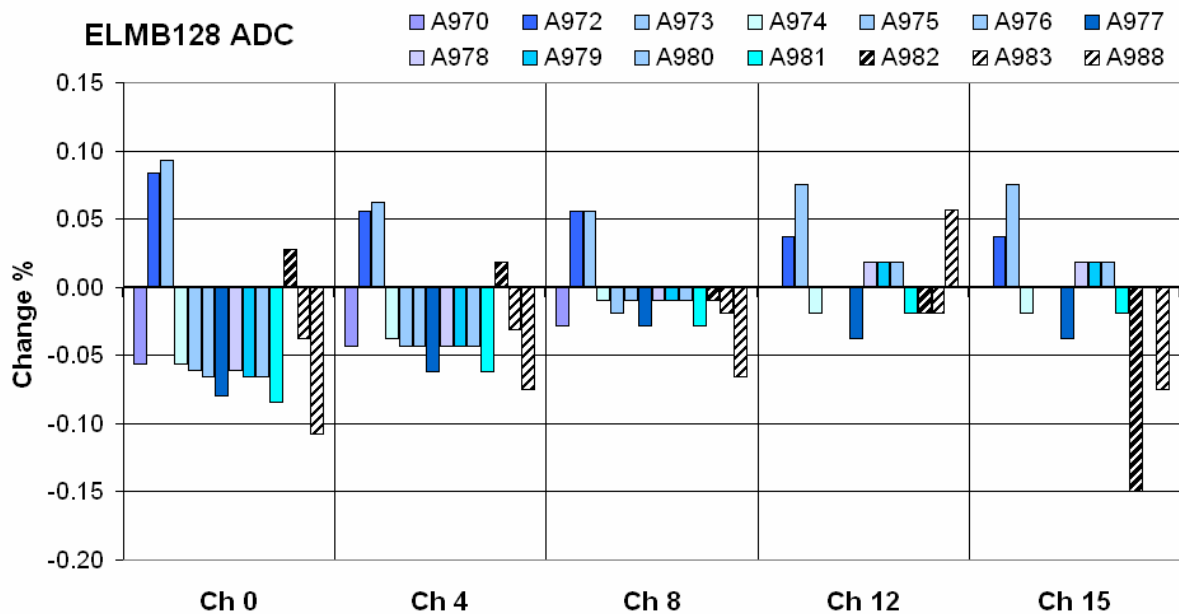
Figure 18 shows the change in the ADC readings in 5 channels. As a comparison three reference ELMB128 boards A982, A983 and A988 that were not subject to any radiation are shown. As seen the changes in the boards subject due to irradiation are negligible.

Figure 18 The change in the readings of 4 ADC channels for each ELMB.  
The A982, A984 and A988 were not irradiated

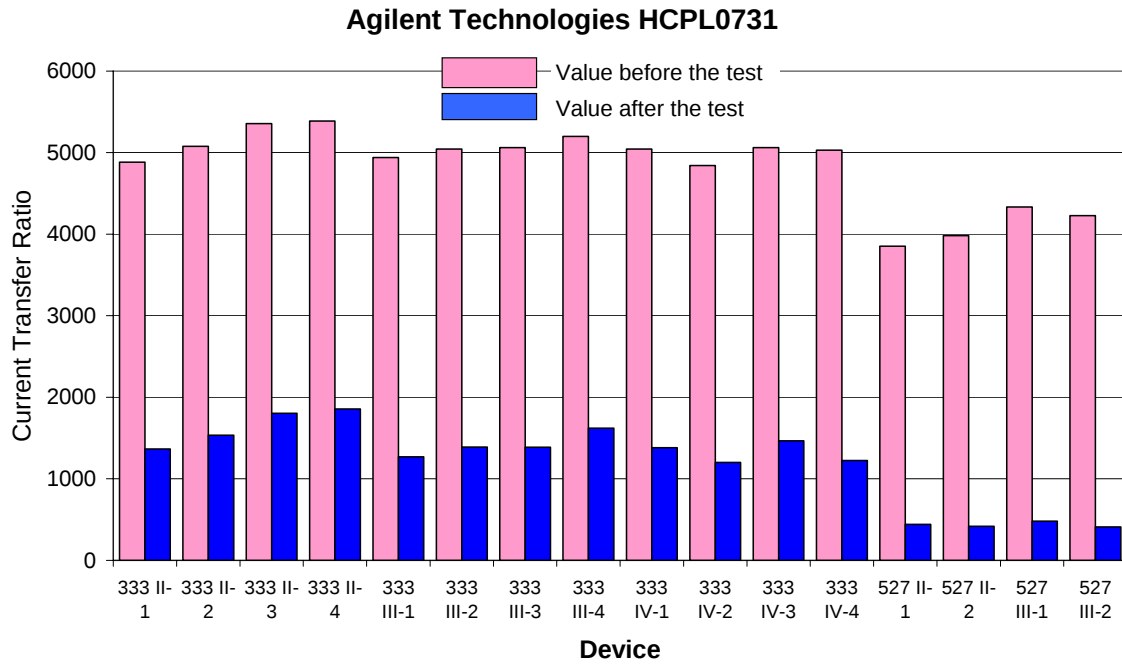
This dual channel optocoupler contains a separated pair of GaAsP light emitting diodes optically coupled to a pair of integrated high gain photo detectors. The current transfer ration is specified to be typically 1800 with min 400 and max 5000. It was discovered during the series production of the ELMB128 that one production lot of optocouplers received (with the date code 333) had gains close to maximum specifications. The optocouplers were placed (not powered) in the proton beam during total duration of the tests. After the irradiation the gain of 333 lot is reduced to 29% respectively while the gain of lot 527 to 89% of the originally value but still within the specifications, see Figure 9. The speed of both series increased as seen in Figure 10.

Figure 9 Change in the current transfer ratio after  $1.2 \cdot 10^{12}$  protons/cm<sup>2</sup>

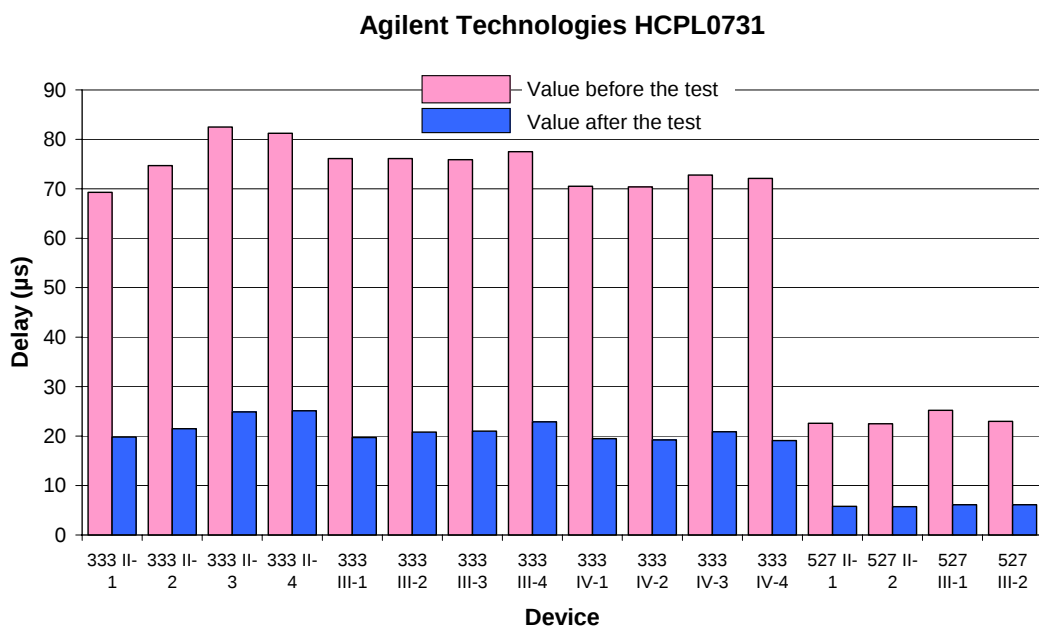
Figure 10 Change in delay of optocouplers for a fluence of  $1.2 \cdot 10^{12}$  protons/cm<sup>2</sup>
