# SEE and TID Qualification of the ELMB128 Series Production

H. Boterenbrood<sup>1</sup> and B. Hallgren<sup>2</sup>

**Abstract:** Twelve ELMB128 boards from the series production were exposed to 60 MeV protons to a total fluence of  $1.2 \cdot 10^{12}$  protons/cm<sup>2</sup>. Each board received concurrently a TID dose of 140 Gy. No destructive or permanent SEE error occurred but one of boards failed during the reprogramming of the flash memory. The number of functional soft SEEs amounted to 3. The different components of the ELMB, ATmega128 processor, CAN controller SAE81C91 and the ADC CS5523 were subject to a systematic study of their SEE cross-section. Measurements were also made on the Agilent Technologies optocouplers HCPL-0731.

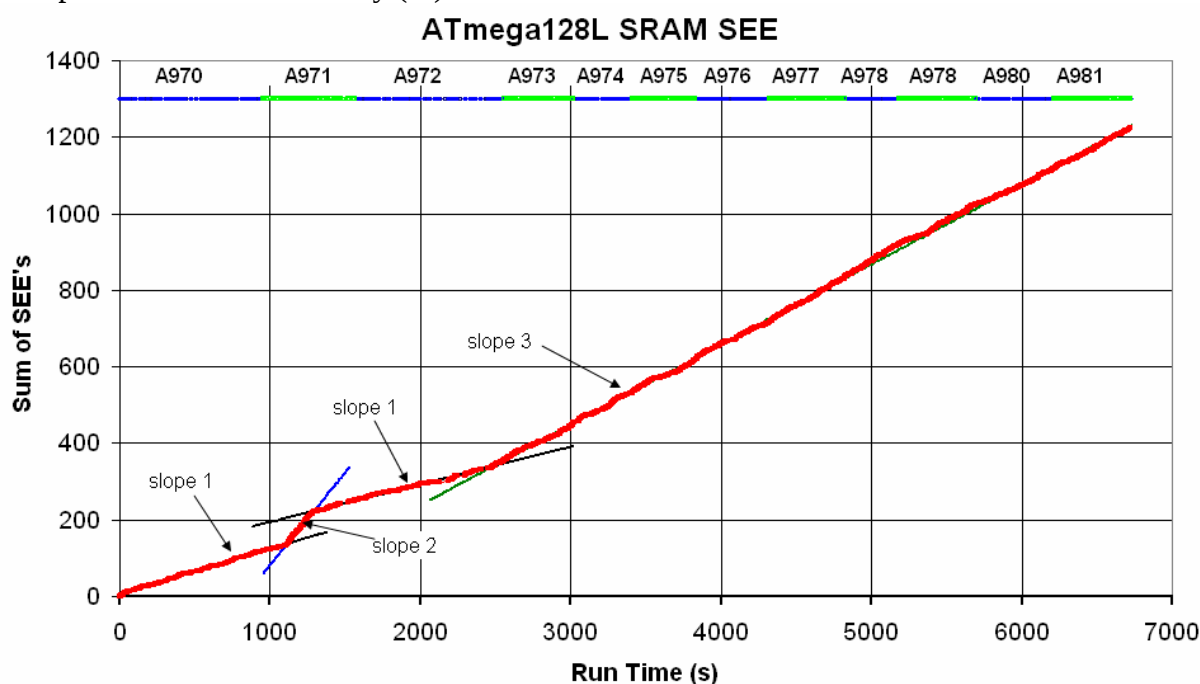
Figure 1 The measured SEE events recorded in the SRAM of the ATmega128 processor as a function of the run time. The three slopes corresponds to a flux of 1, 2 respectively  $5 \cdot 10^8$  protons\*cm<sup>-2</sup>\*s<sup>-1</sup>
